# CENTRAL VALLEY FLOOD MANAGEMENT PLANNING PROGRAM

## Flood Control System Status Report Appendix A – Levee Status

December 2011

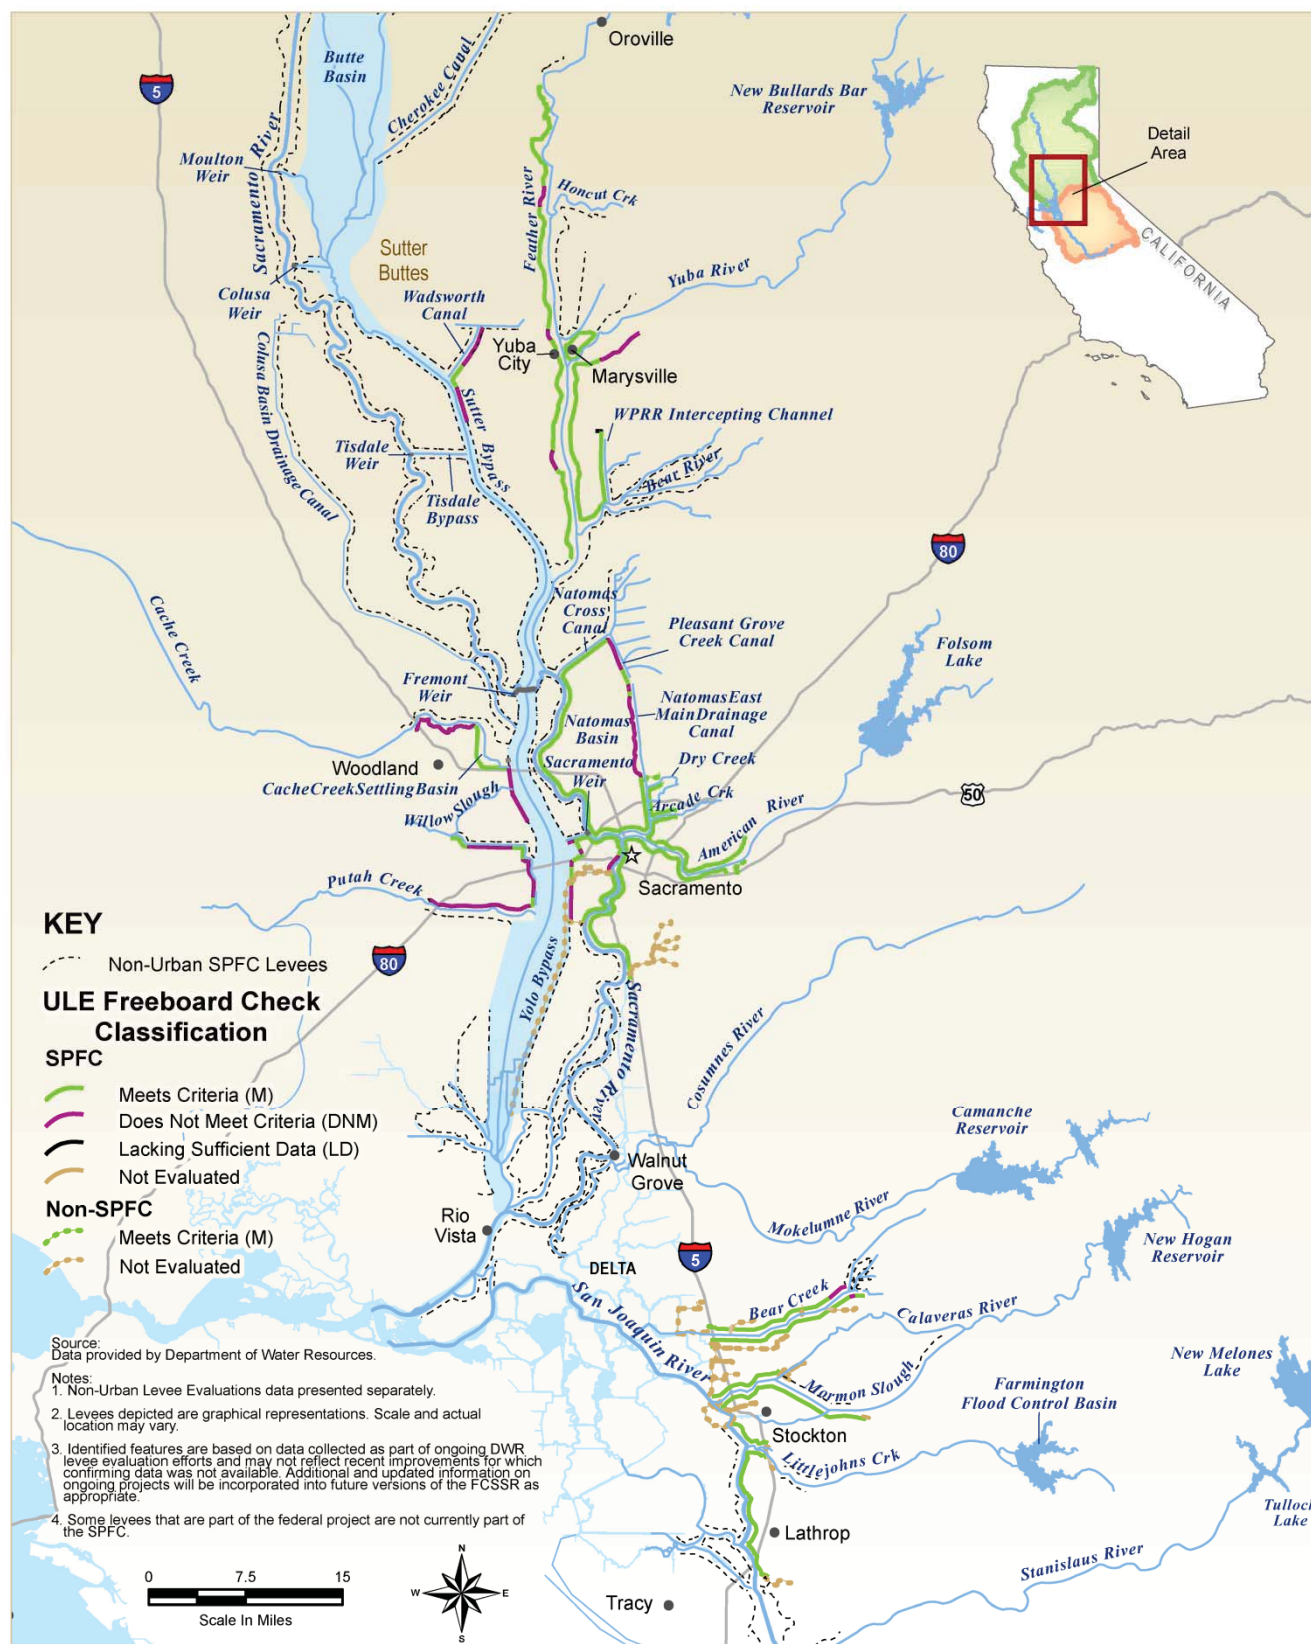
Figure A-6. ULE Freeboard Check Results

ULE freeboard check results are shown on Figure A-6. Levees that do not meet freeboard criteria include portions of the Pleasant Grove Creek Canal and Natomas East Main Drainage Canal, the south bank of the Yuba River east of Marysville, the Davis/Woodland area and along Upper Bear Creek.

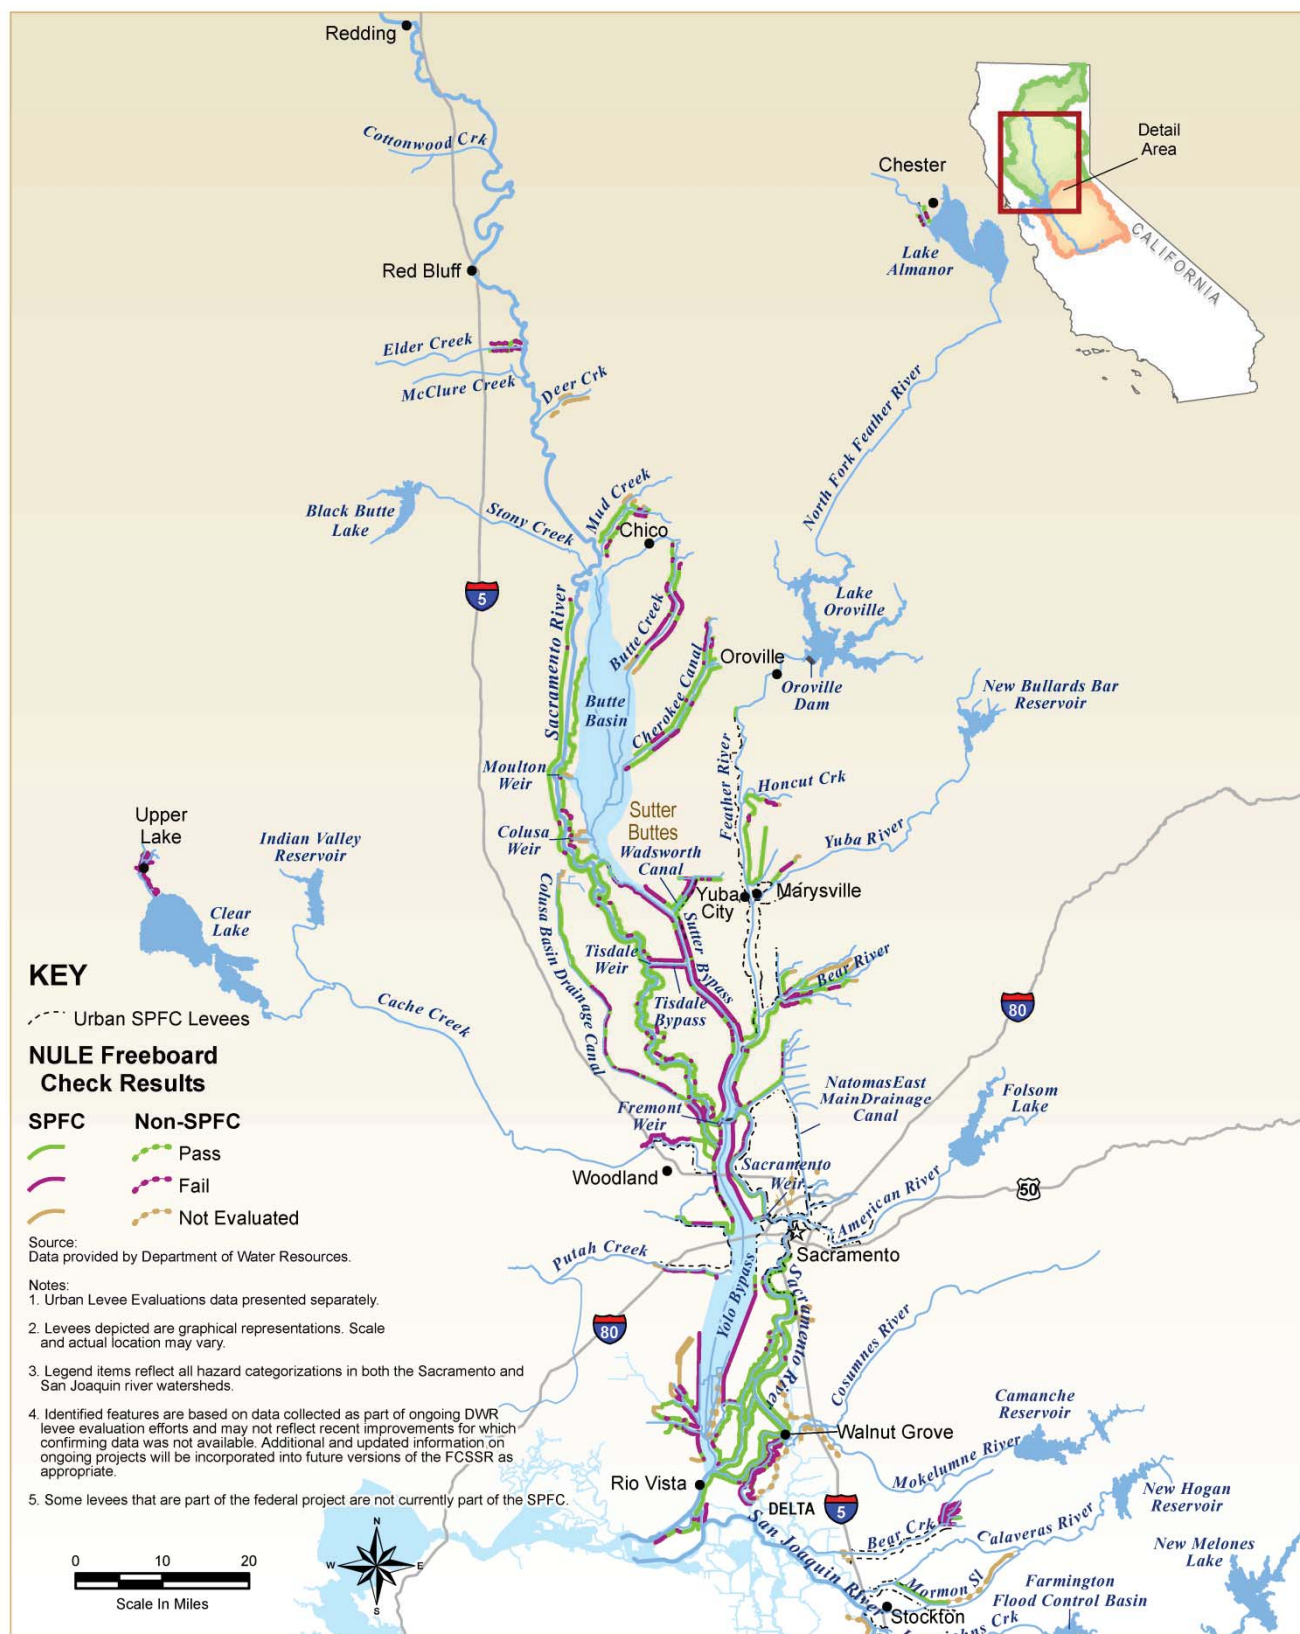
Figure A-7. NULE Freeboard Check Results in Sacramento River Watershed

Figures A-7 and A-8 show a pass or fail result for NULE levee segments in both the Sacramento and San Joaquin river watersheds regarding whether they meet freeboard requirements. Freeboard results show that portions of both banks of the Sutter Bypass, both banks of the Yolo Bypass, Butte Creek, Colusa Basin Drainage Canal, and the Bear River do not meet freeboard criteria. Compliance with freeboard criteria is variable in other areas within the Sacramento River watershed. In the San Joaquin River watershed, levee reaches along the lower Stanislaus River, lower Tuolumne River, San Joaquin River downstream of Merced River, upper Bear Creek and Paddy Creek do not meet freeboard criteria.

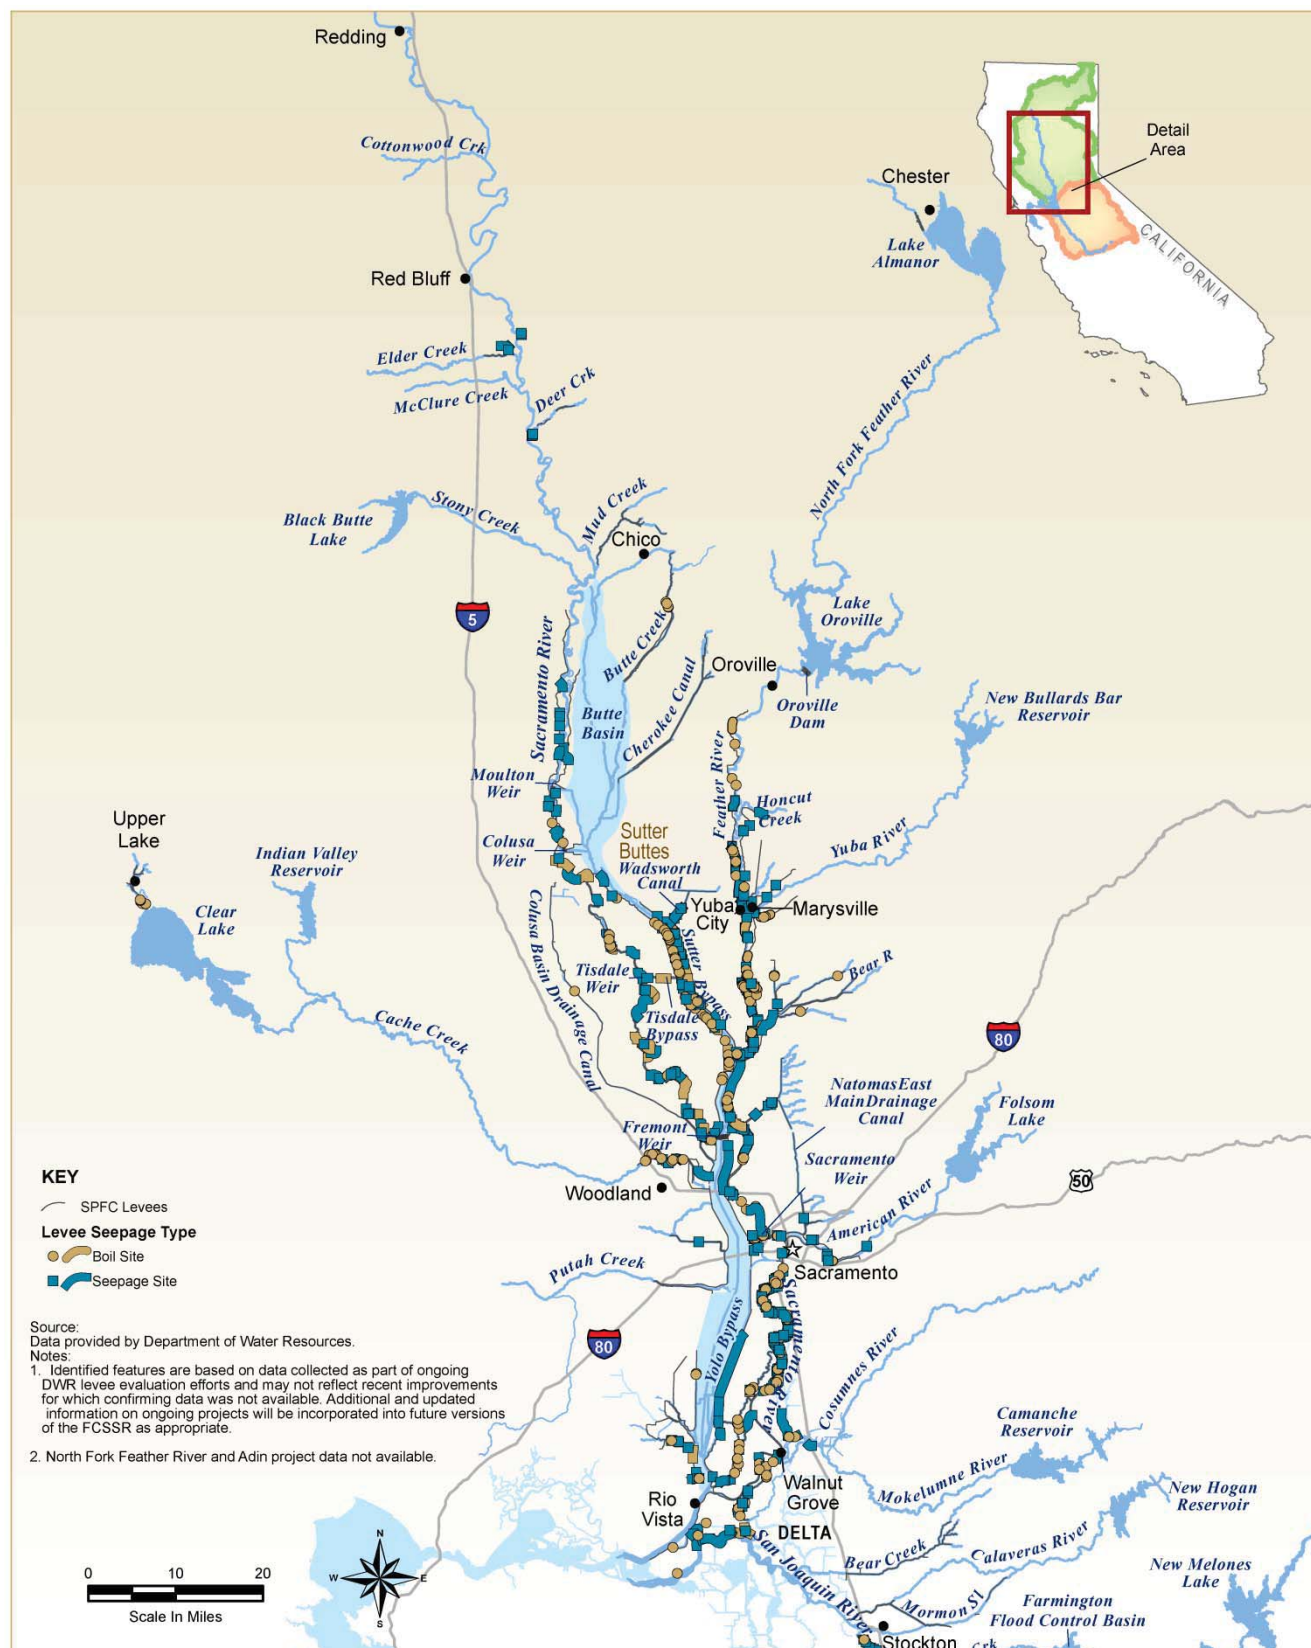
improvements. Figures A-11 and A-12 show historical seepage occurrences collected by the ULE and NULE projects in the Sacramento and San Joaquin river watersheds, respectively. In the Sacramento River watershed, historical seepage occurrences were located throughout the system and were particularly prevalent along the Sutter Bypass and Sacramento River south of Sacramento. In the San Joaquin River watershed, most historical seepage occurrences were along the San Joaquin River and Eastside Bypass.

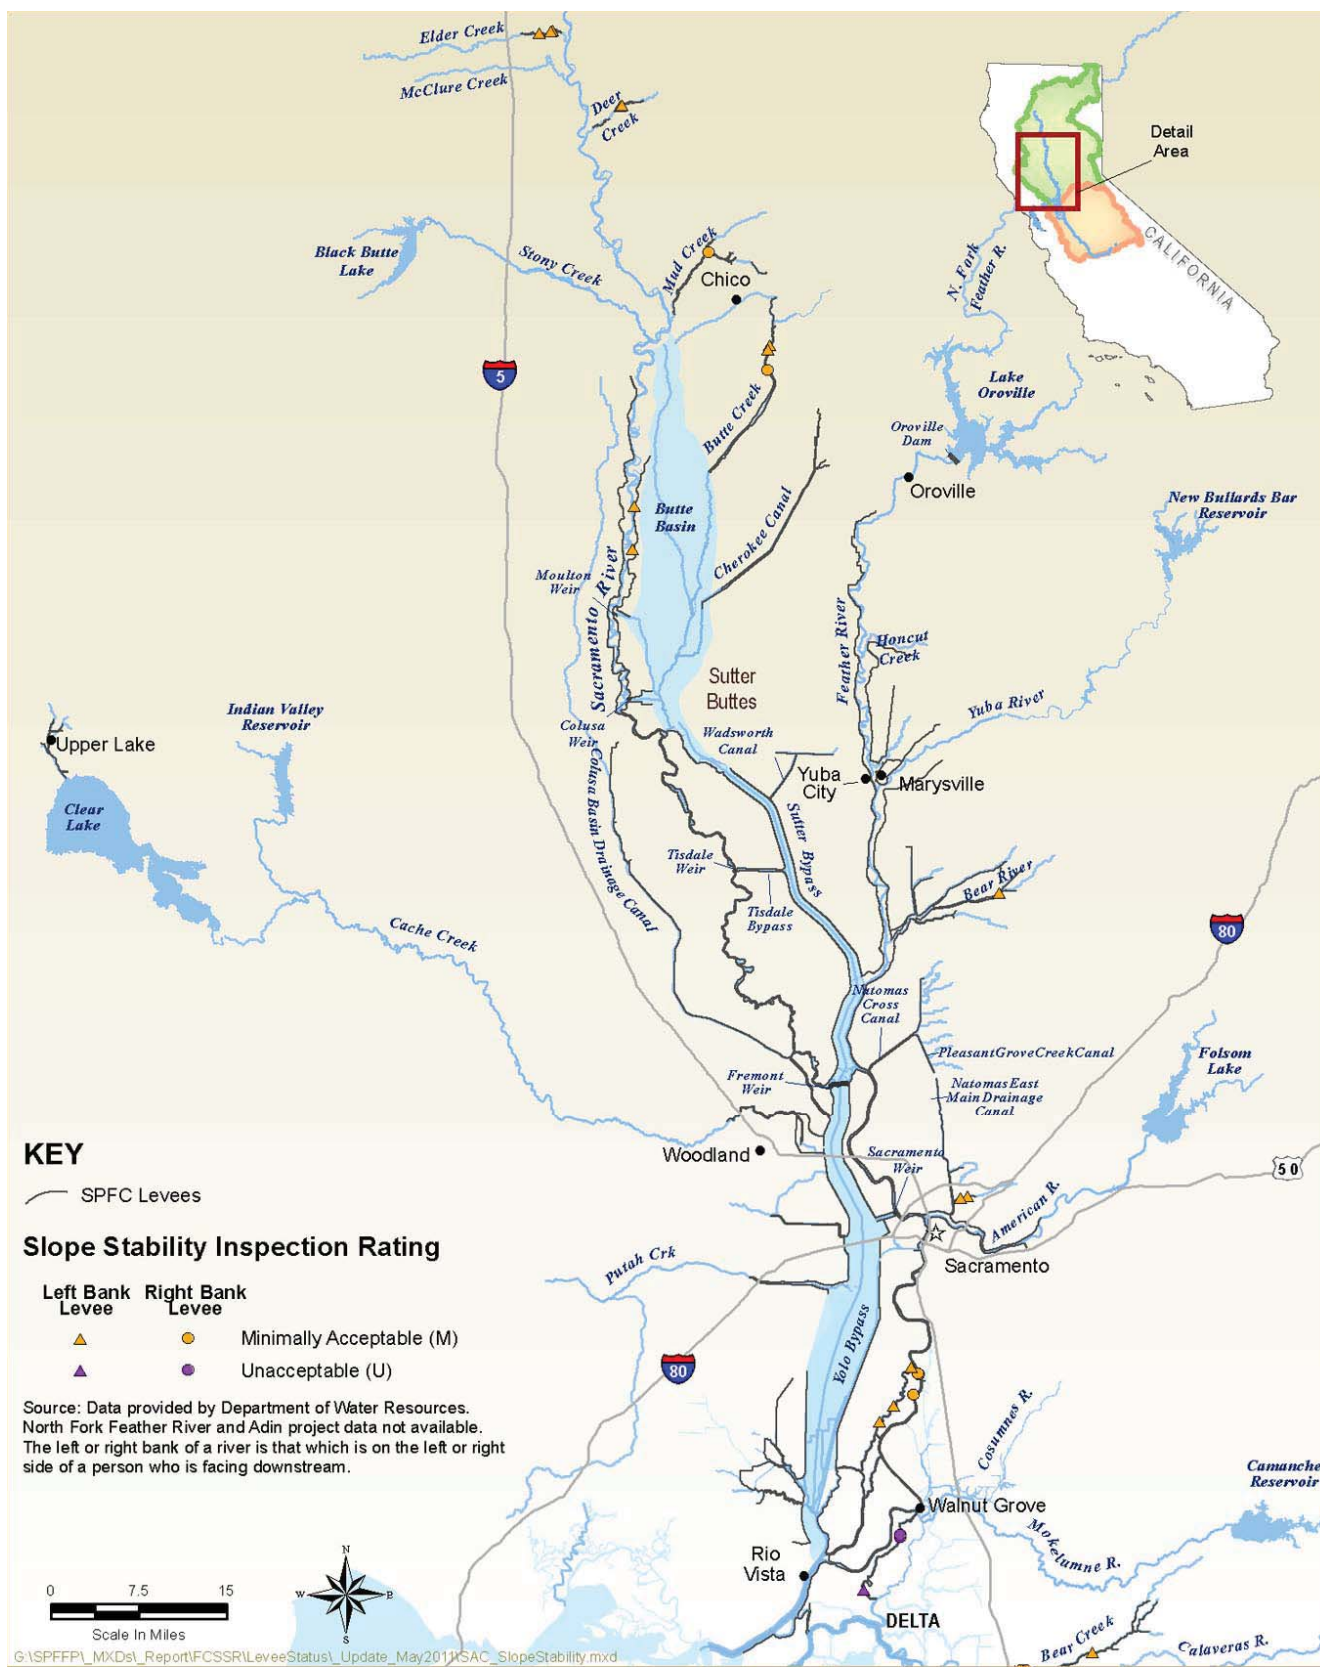
**Figure A-17. 2009 Slope Stability Inspection Ratings in Sacramento River Watershed**

are shown on Figures A-17 and A-18. Two sites with Unacceptable ratings for slope stability are located in the Delta. In the Sacramento River watershed has no Unacceptable ratings, but several sites, in various locations, have Minimally Acceptable ratings. In the San Joaquin River, Minimally Acceptable ratings are located on the lower San Joaquin River, Bear Creek, Mormon Slough, and Littlejohns Creek.

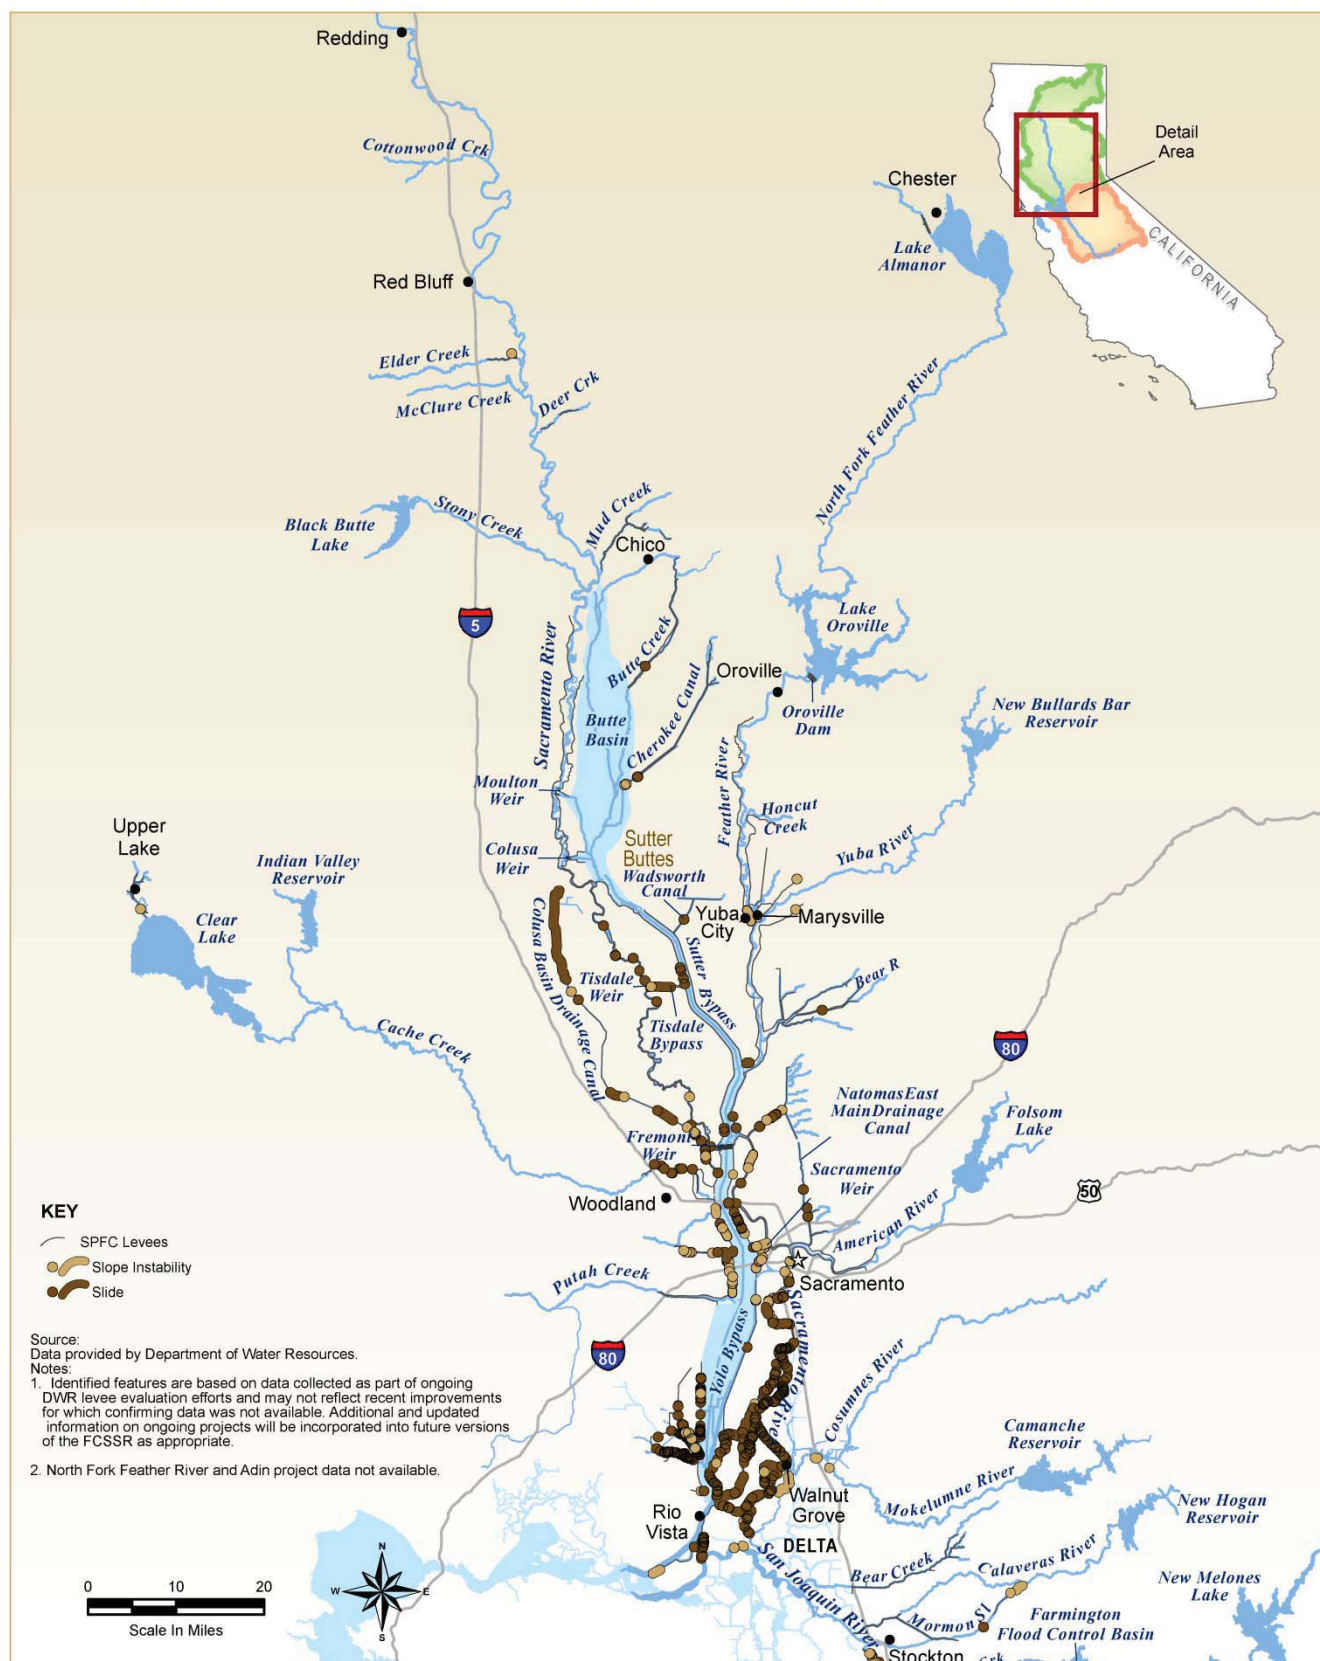
Figure A-19. Historical Slope Instability Occurrences in Sacramento River Watershed

The ULE and NULE projects collected and cataloged information on historical occurrences of levee slope instability. Figures A-19 and A-20 show historical slope instability occurrences collected from the ULE and NULE projects for the Sacramento and San Joaquin river watersheds, respectively. In the Sacramento River watershed, historical levee slope instability occurrences were located most frequently in the lower Sacramento River watershed south of the Fremont Weir. Slope instability was most prevalent on the Sacramento River south of Sacramento and in the north Delta. In the San Joaquin River watershed, historical levee slope instability occurrences were prevalent through the watershed.

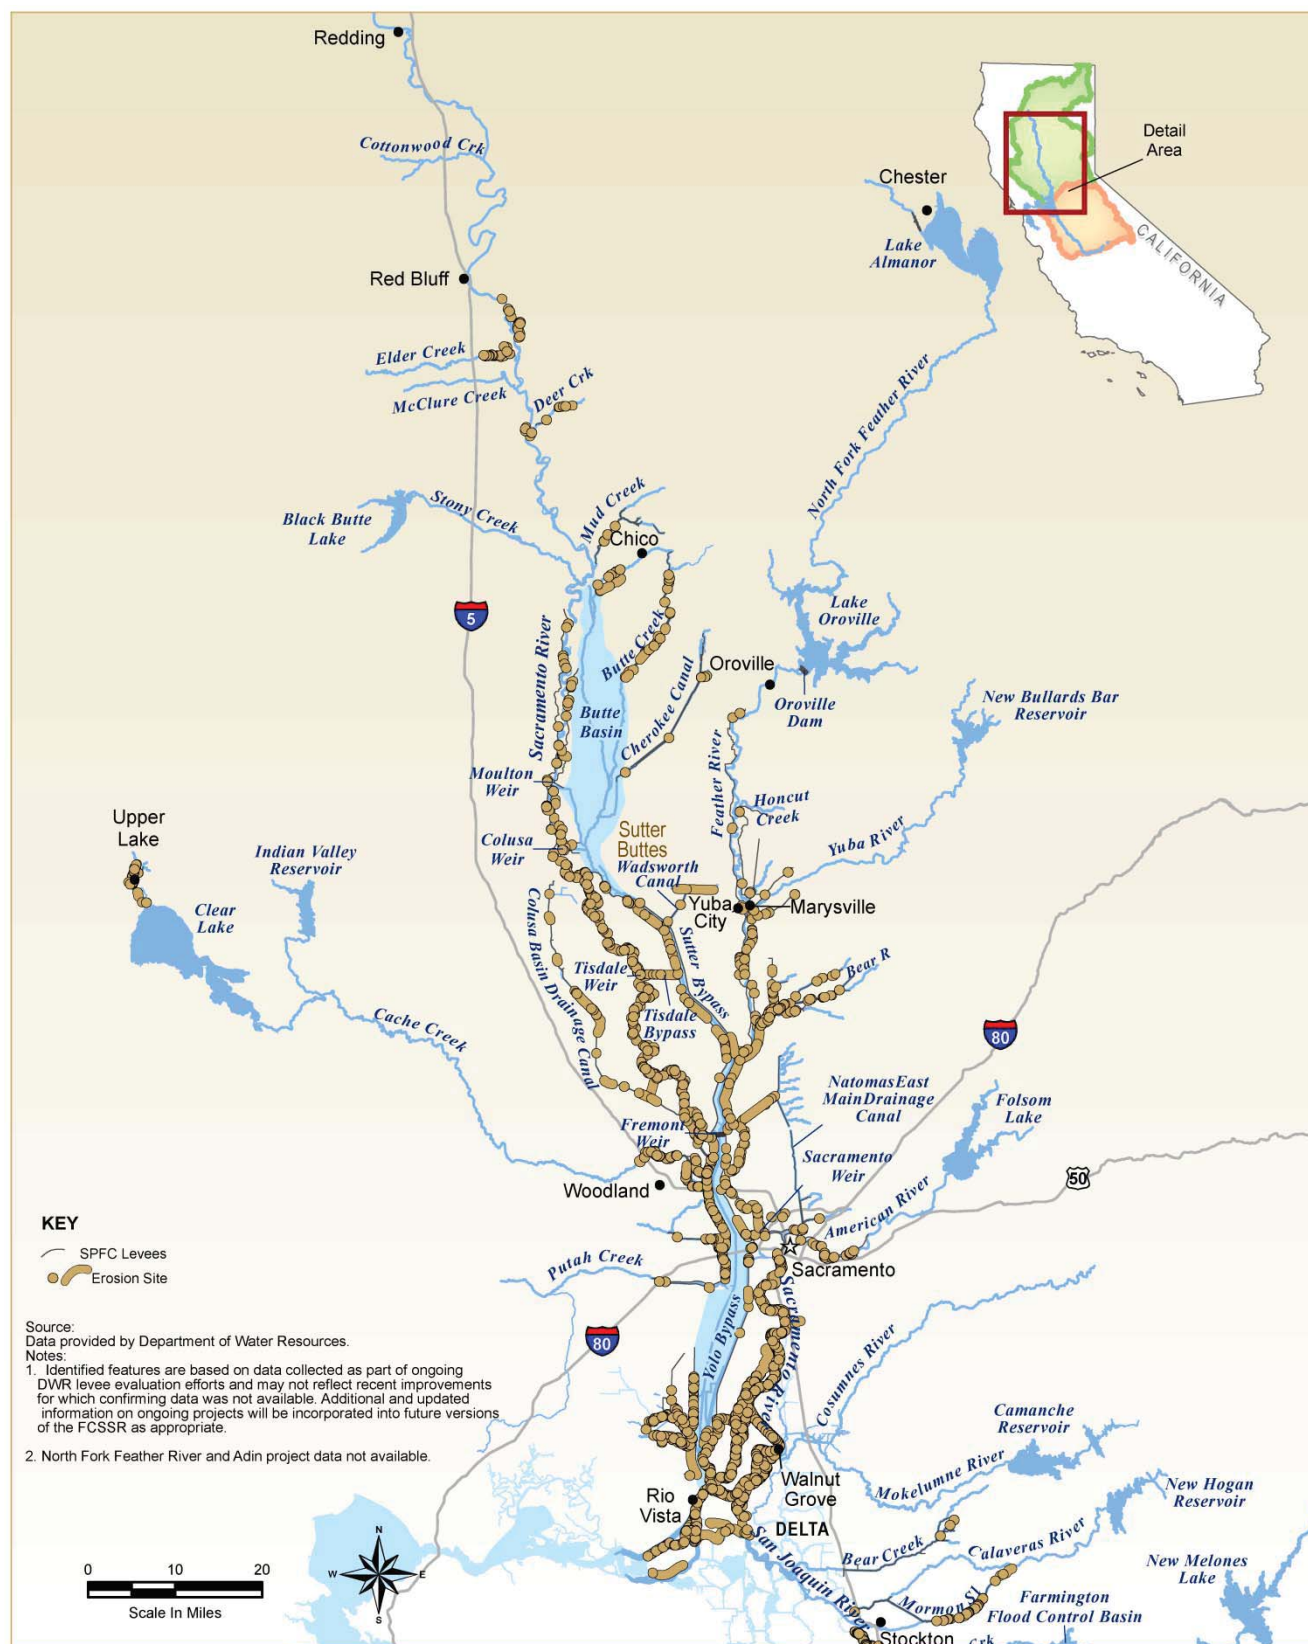
Figure A-23. Historical Erosion Occurrences in Sacramento River Watershed

The ULE and NULE projects collected and cataloged information on historical occurrences of levee erosion and completed or planned repairs or improvements. Figures A-23 and A-24 show historical erosion occurrences for the Sacramento and San Joaquin river watersheds, respectively. Historical erosion occurrences were located throughout almost all SPFC levees of the Sacramento and San Joaquin river watersheds.

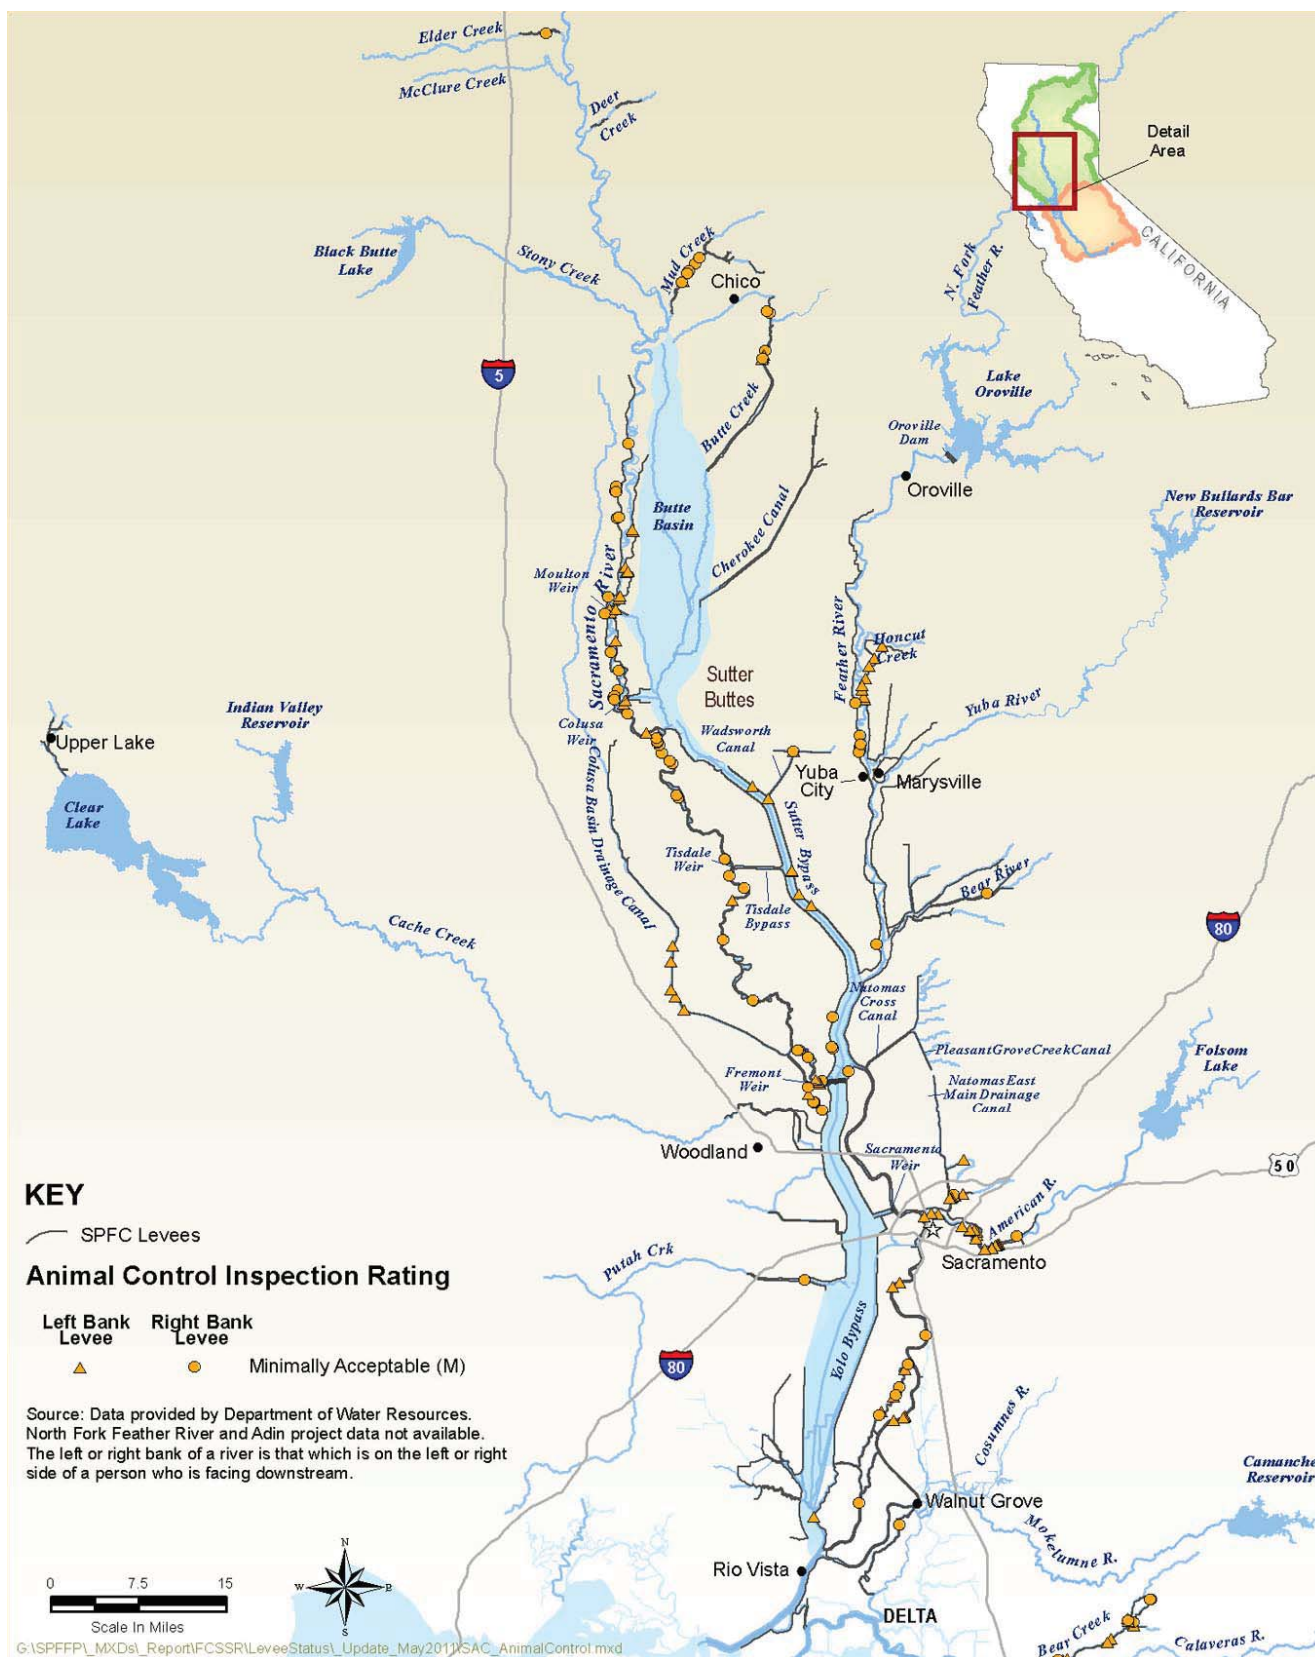
Figure A-32. 2009 Animal Control Inspection Ratings in Sacramento River Watershed

Animal control inspection ratings from the *2009 Annual Inspection Report* (DWR, 2010b) are shown on Figures A-32 and A-33 for the Sacramento and San Joaquin river watersheds, respectively. The inspection data show that several levees were given Minimally Acceptable ratings across the Sacramento River watershed, especially along the upper Sacramento River north of Fremont weir, American River, and Feather River. In the San Joaquin River watershed, Unacceptable and Minimally Acceptable ratings are prevalent throughout the watershed.
